Philco 39-25 Restoration

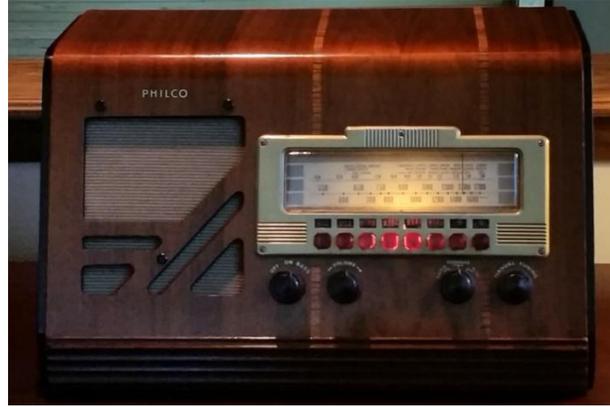
Picked up this radio on ebay for about \$60 including shipping. Looks like it was in pretty tough shape but I'm glad I got it as it turned out great. After taking

apart the cabinet I cleaned it up with Citristrip. Below are some of the photos from dismantling the cabinet including the left-over food stores from previous tenants:

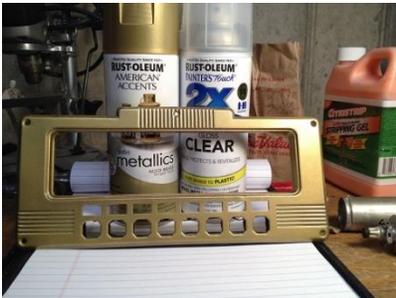
The brass escutcheon was cleaned with soap and water followed by some Simichrome metal polish. More polishing could have made the brass very shiny but that is not the way the original looked. They had a gold colored paint look rather than shiny brass. This was achieved after viewing Bob Andersen's youtube videos on restoring a 39-30 with American Accents aged brass paint and Krylon clear gloss coat.

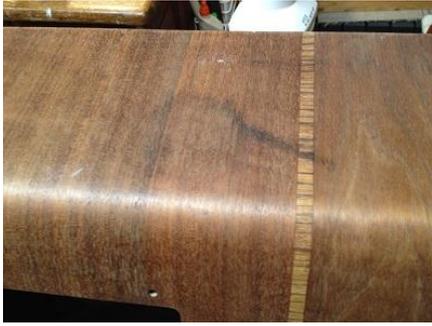
Before treatment

The top of the cabinet had a black water stain that I thought I would have to live with but it came out with the use of an oxalic acid wood bleach product that I had tried before with limited success. I think my earlier problem was that I did not leave it on the wood long enough and had not worked it into the wood with a toothbrush. You can see the results of it this time in the following photos:

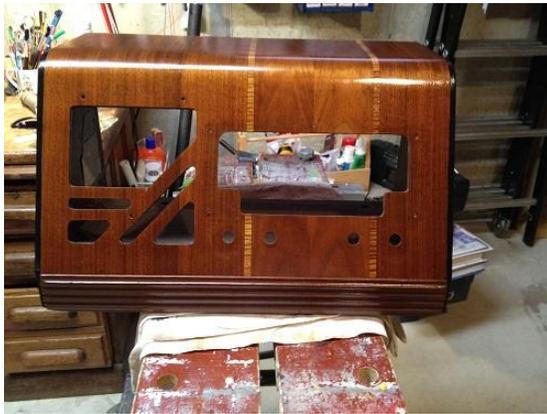
After some toning with Mohawk Ultraclassic Medium Brown Walnut on the main portion of the cabinet; Behlen Medium Brown Walnut on the bottom molding strip in the front and some Americana acrylic black on the outer trim, the first couple of gloss lacquer coatings made it look pretty good.

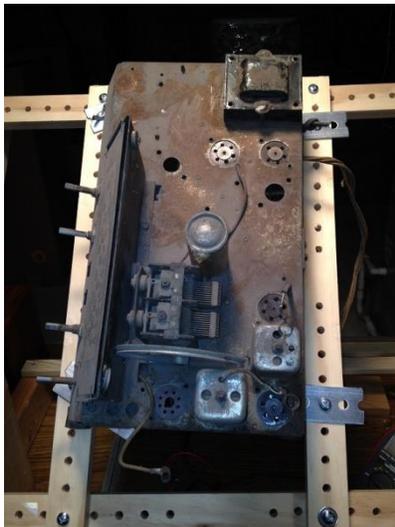
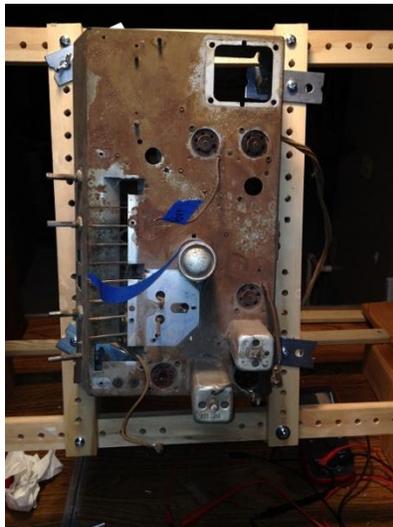
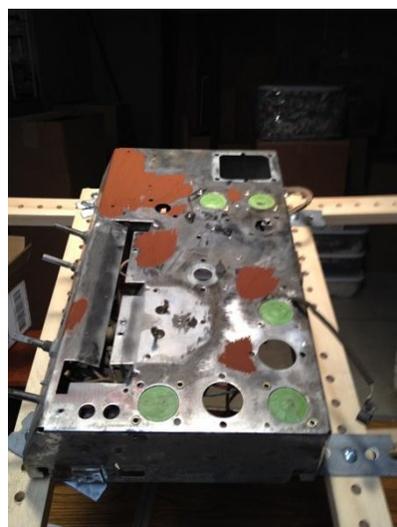
The chassis was in a bad state because of rusting with pitting caused by the mice that were living in the cabinet. To repair I decided that there was enough rusting that I should at least paint the top of the chassis. This required disassembly of the chassis, wire brushing & naval jelly treatment:

The pits were primed with Rustoleum and sanded flat and then the chassis was painted with Rustoleum Aluminum. Painting the chassis meant that the original model number stamp markings were lost. I replaced these using an ink transfer process that I found on-line.

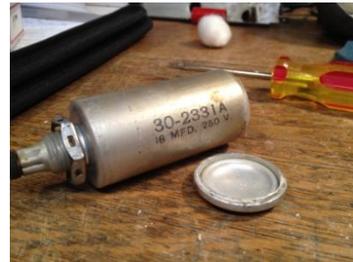
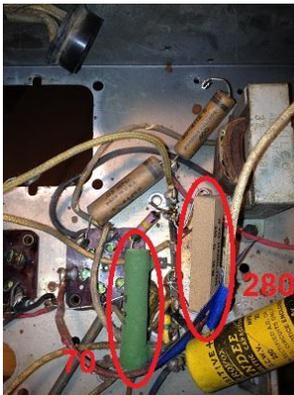
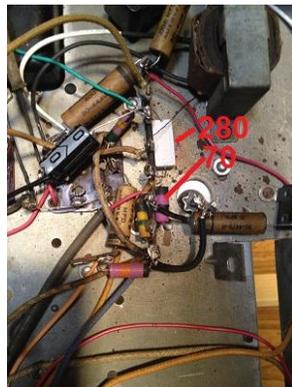
Two of the three electrolytic capacitor cans were missing in this chassis and older repairs had all the electrolytics tacked in under the chassis. I was able to find one can on-line that was similar though not identical to the 30-2330A and 30-2331A cans I needed so I used it to restuff one of the electrolytics,

restuffed the remaining original can and tacked one in under the chassis.

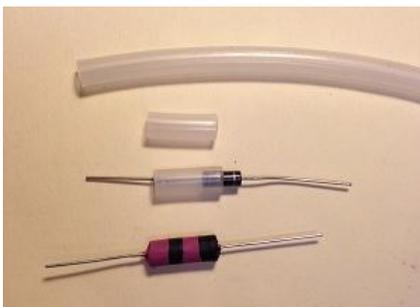
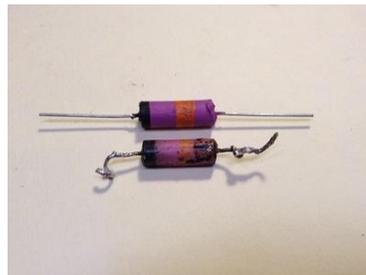
There was also an ugly repair of the wire wound resistor and a 70 ohm resistor. I replaced the 280 ohm resistor with a smaller 5 watt 300 ohm resistor that was less obvious under the chassis and I built a replacement 70 ohm resistor that looked like an original would. Other resistors that were out of spec were also replaced with

reproductions. The reproductions were made with a piece of tubing with a new resistor placed inside and then sealed with a little hot glue. The tubing was lightly sanded and Americana acrylic paints were used to create the right colors for the resistors.

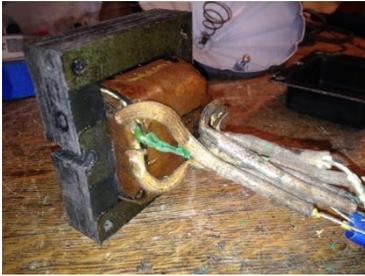
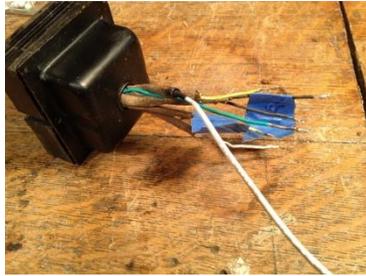
All of the paper and bakelite block capacitors were stuffed with new 630 volt caps and much of the rubber wiring was replaced since it was becoming brittle. This included putting sleeve insulation on the power transformer wiring:

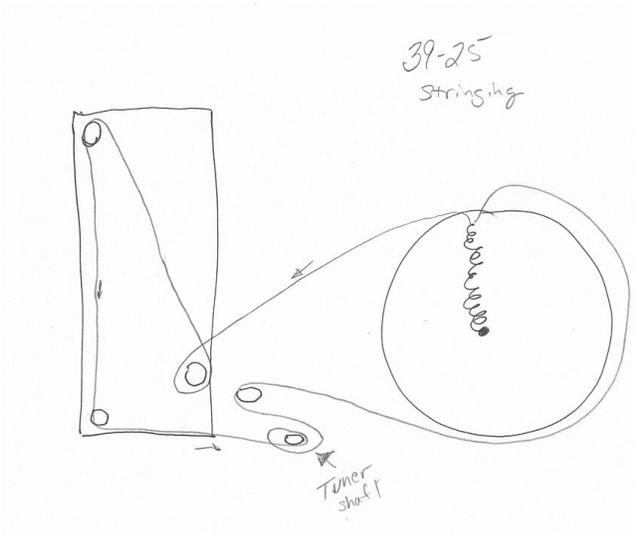
Restrung the tuning dial and capacitor was necessary since I had disassembled the chassis. A stringing diagram is shown below, although in practice I wrapped the tuner shaft pulley twice rather than once as shown in the diagram.

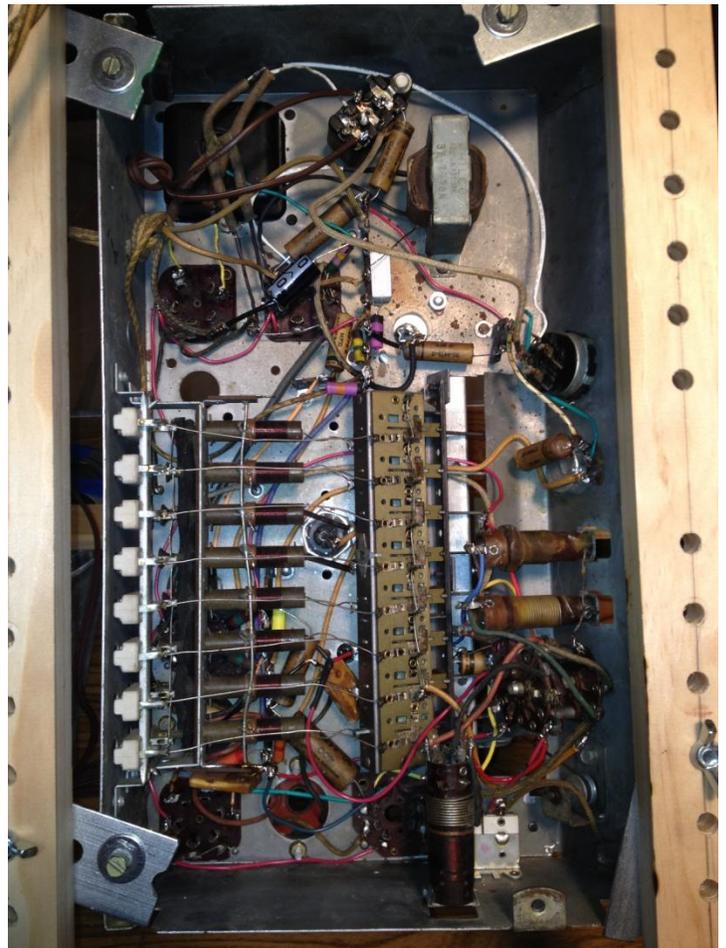
Underside of the chassis after all the repairs and replacements were made:

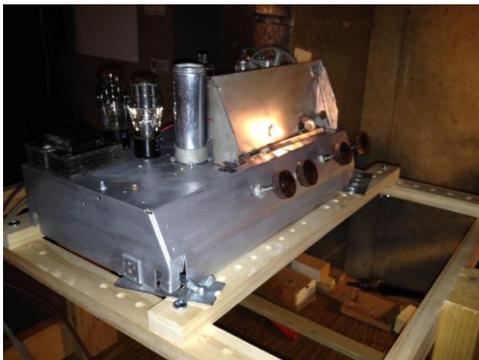
Top of chassis just about ready to put back into the cabinet:
